SERVICE INFORMATION LETTER

Clarification on the Engine Isolator Inspection Criteria

LM-827-SA2, -SA7, -SA10, -SA11

LM827-71-001

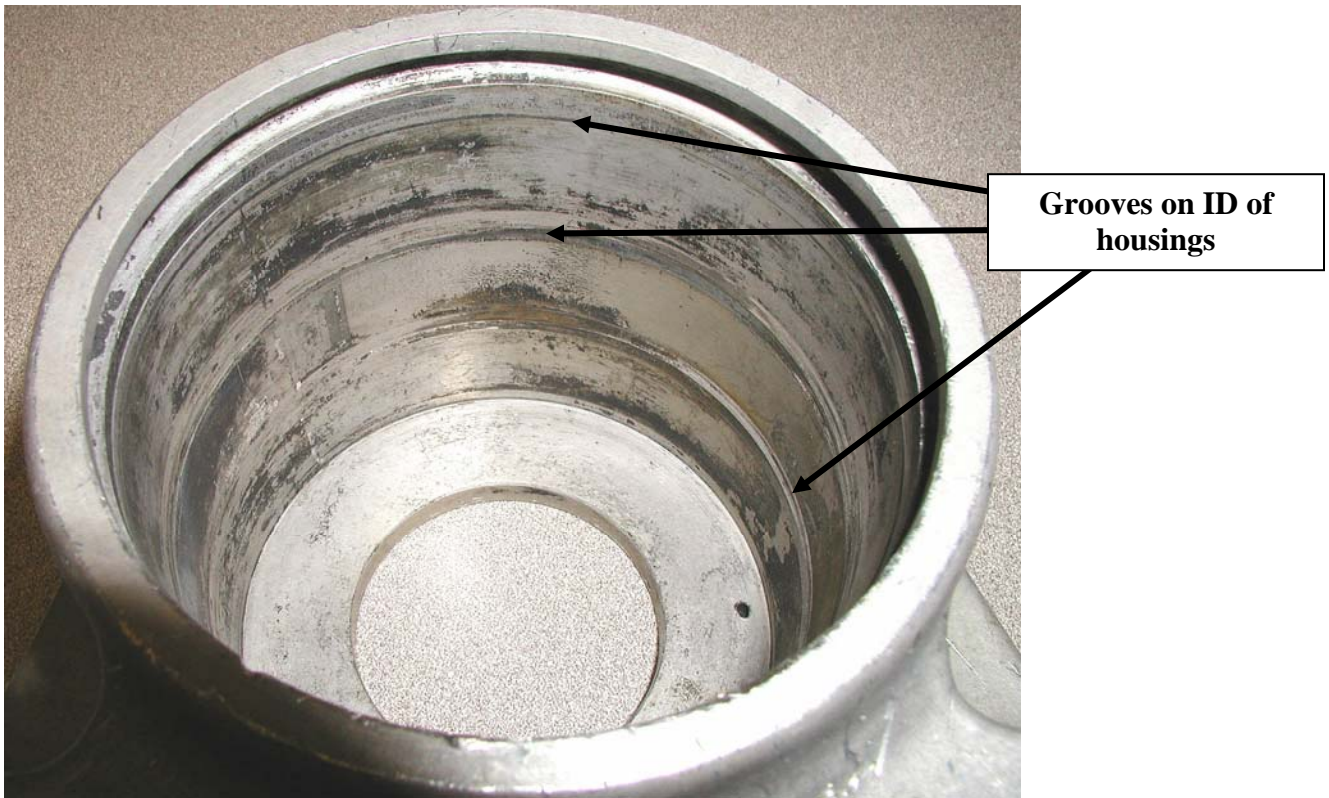
FIGURE 1

1. It has come to Lord Corporation's attention that the housings for the LM-827-SA2, -SA7, -SA10 and -SA11 have some excessive wear and damage both on the exterior of the housing and the inner diameter. The CMM is somewhat vague for these parts and this service letter will clarify the inspections.
2. With time, wear takes place between the rubber sandwiches and the inner diameter of the housing resulting in grooves in the housing as shown in Figure 1.

3. These grooves should be machined out locally (the entire ID of the housing does not have to be machined, just where the groove has formed) with 64 micro-inches maximum surface finish with a minimum transition radius of .075 inches (no sharp edges). The maximum inner diameter is as follows:

- The inner diameter for the LM-827-SA10 housing, LM-827-46, should have a maximum diameter of 3.617 inches. If this value is exceeded, the part should be replaced.

- The inner diameter for the LM-827-SA11 housing, LM-827-45, should have a maximum diameter of 3.077 inches. If this value is exceeded, the part should be replaced.

- The inner diameter for the LM-827-SA2 housing, LM-827-15, should have a maximum diameter of 3.077 inches. If this value is exceeded, the part should be replaced.

- The inner diameter for the LM-827-SA7 housing, LM-827-35, should have a maximum diameter of 3.077 inches. If this value is exceeded, the part should be replaced.

- If there remains some local wear or damage to the inner diameter after machining, it is acceptable to polish this area (to a 64 micro-inches maximum surface finish with .075 inch minimum radius) if the area is less than an inch long and does not exceed .030 inches deep from the original surface prior to machining the inner diameter. If this is exceeded, replace the part.
